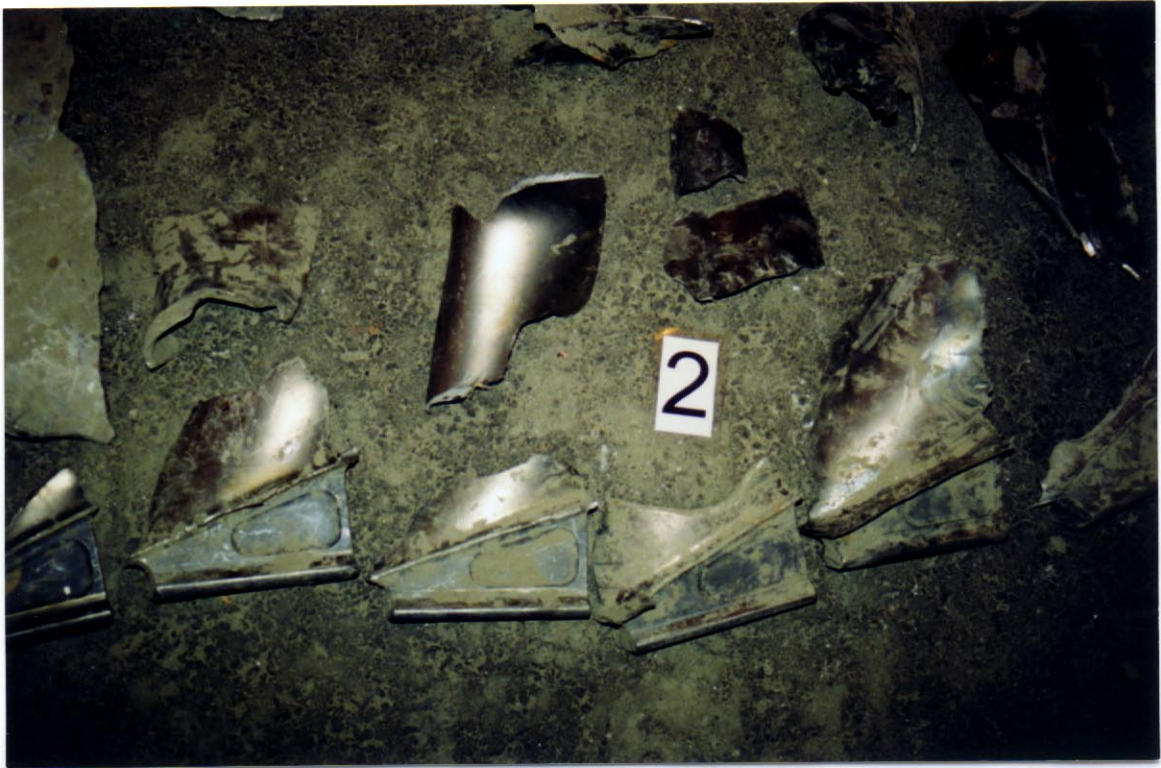
Photo 10. Pieces of No. 2 engine fan blades.

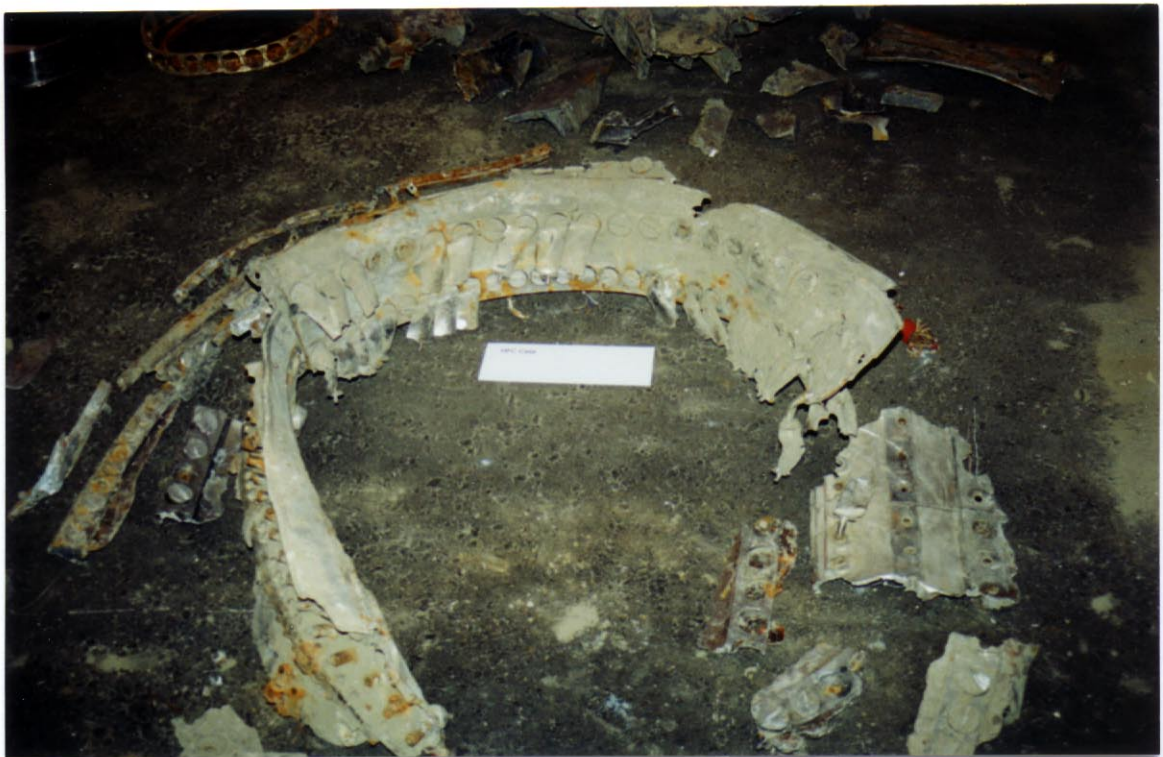
Photo 13. View of No. 2 engine HPC case showing variable stator vanes bent rearward.

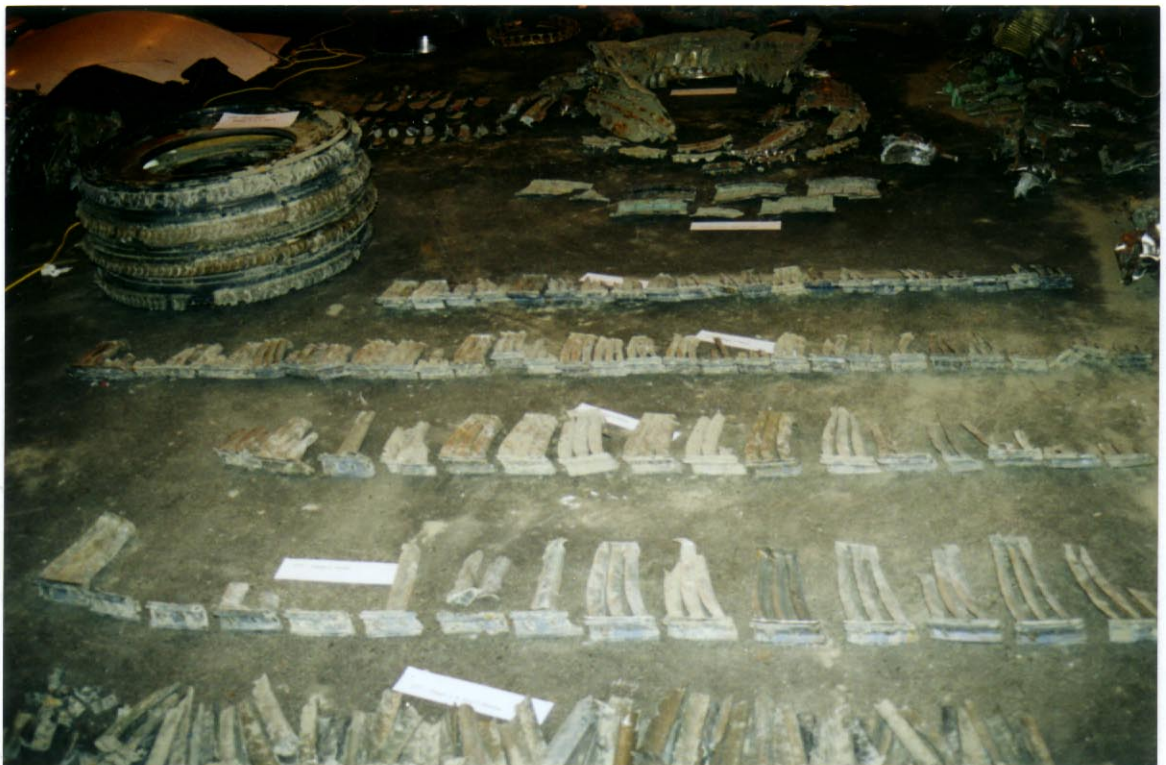
Photo 23. No. 2 engine LPT vanes showing straight airfoils and random lengths.

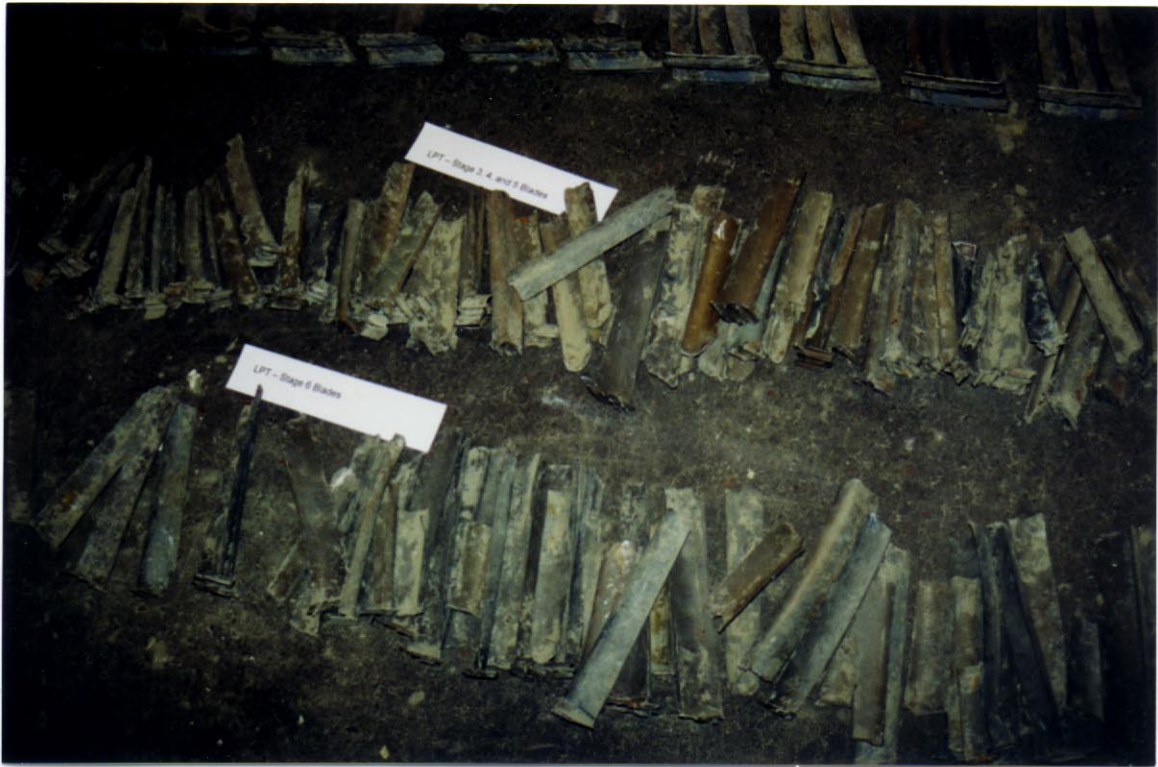
Photo 24. No. 2 engine LPT blades showing full length airfoils.

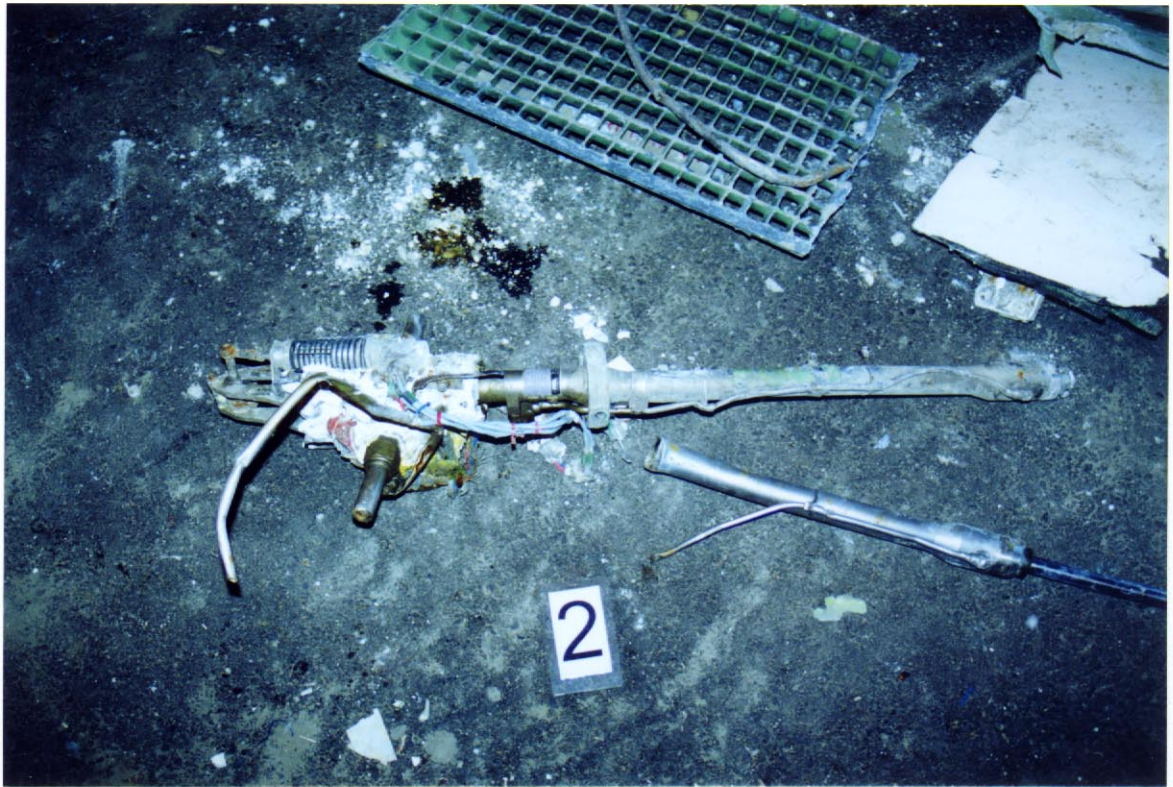
Photo 28. View of No. 2 engine thrust reverser actuator in the reverser-stowed position.

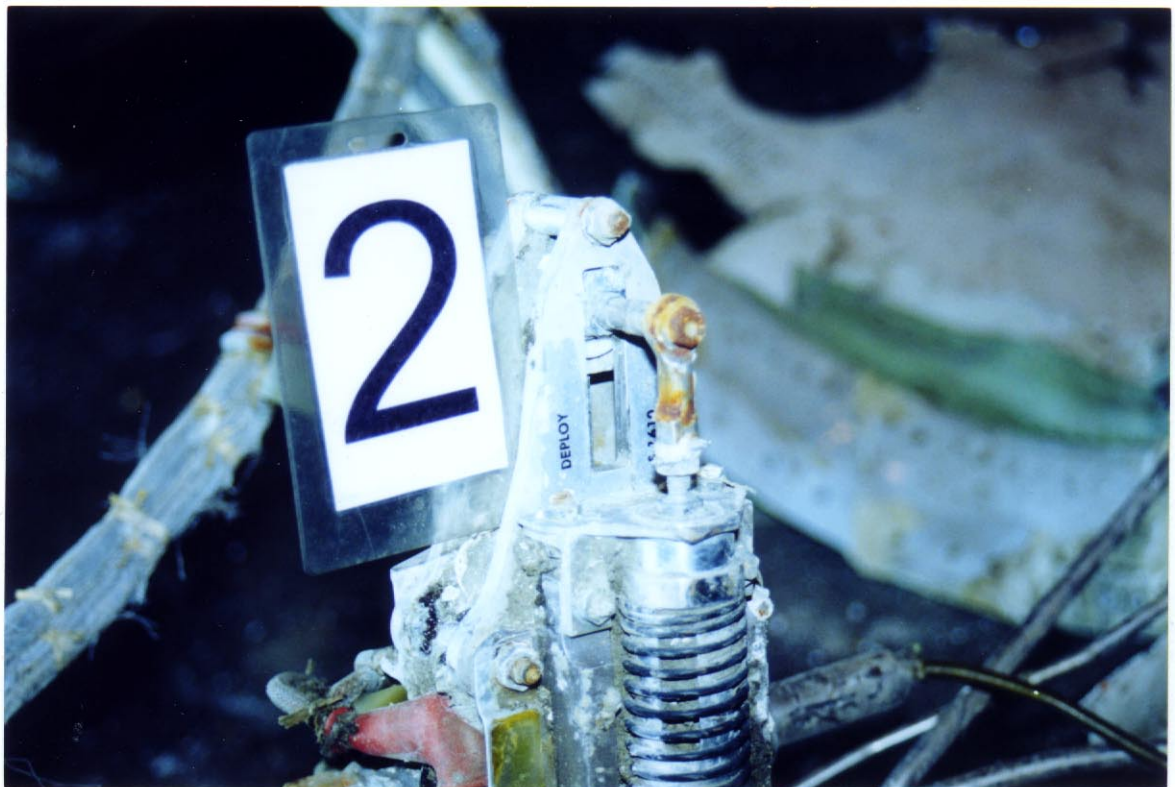
Photo 29. Closeup of No. 2 engine thrust reverser actuator showing indicator pin in reverser-stowed position.
