EGYPTIAN CIVIL AVIATION AUTHORITY

Addendum 1 to the
REPORT OF INVESTIGATION OF ACCIDENT
EgyptAir Flight 990
October 31, 1999
Boeing 767-300ER SU-GAP
Atlantic Ocean – 60 Miles Southeast of Nantucket Island

November 2, 2001

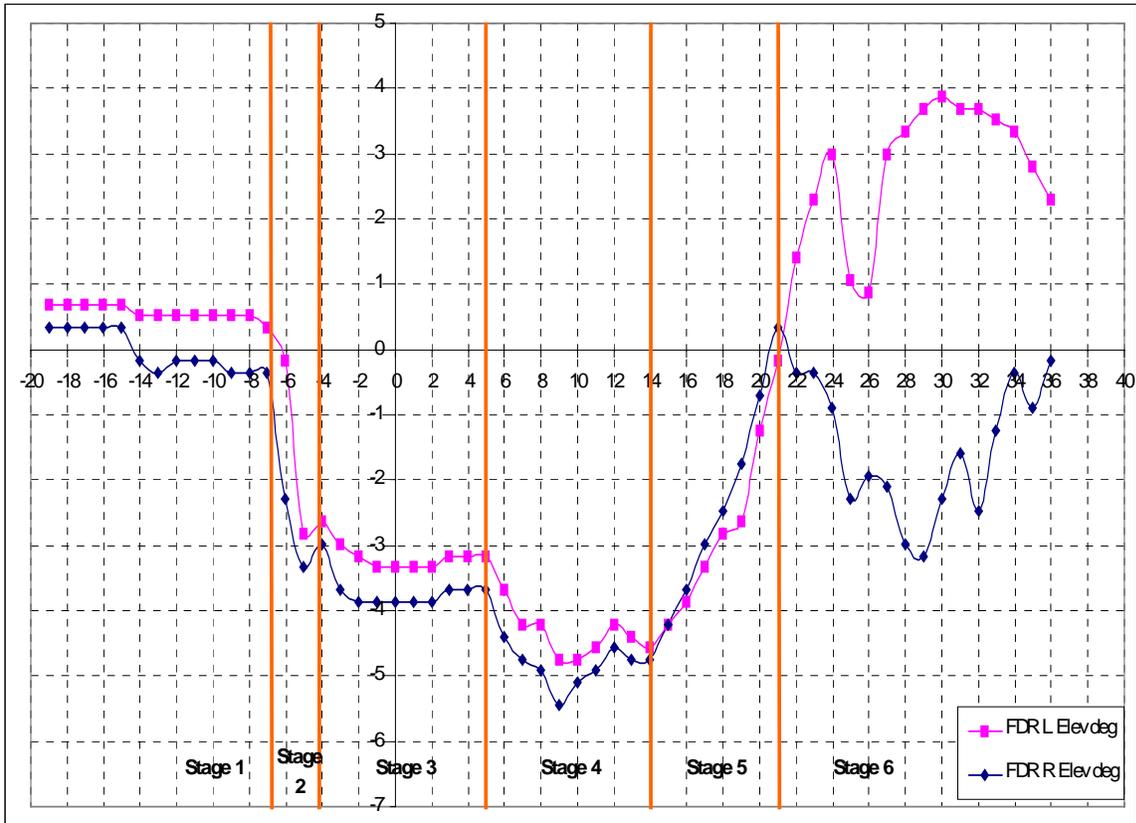
Figure 5, Elevator stages during the dive

For reference, Figure 5 shows the different stages for the dive

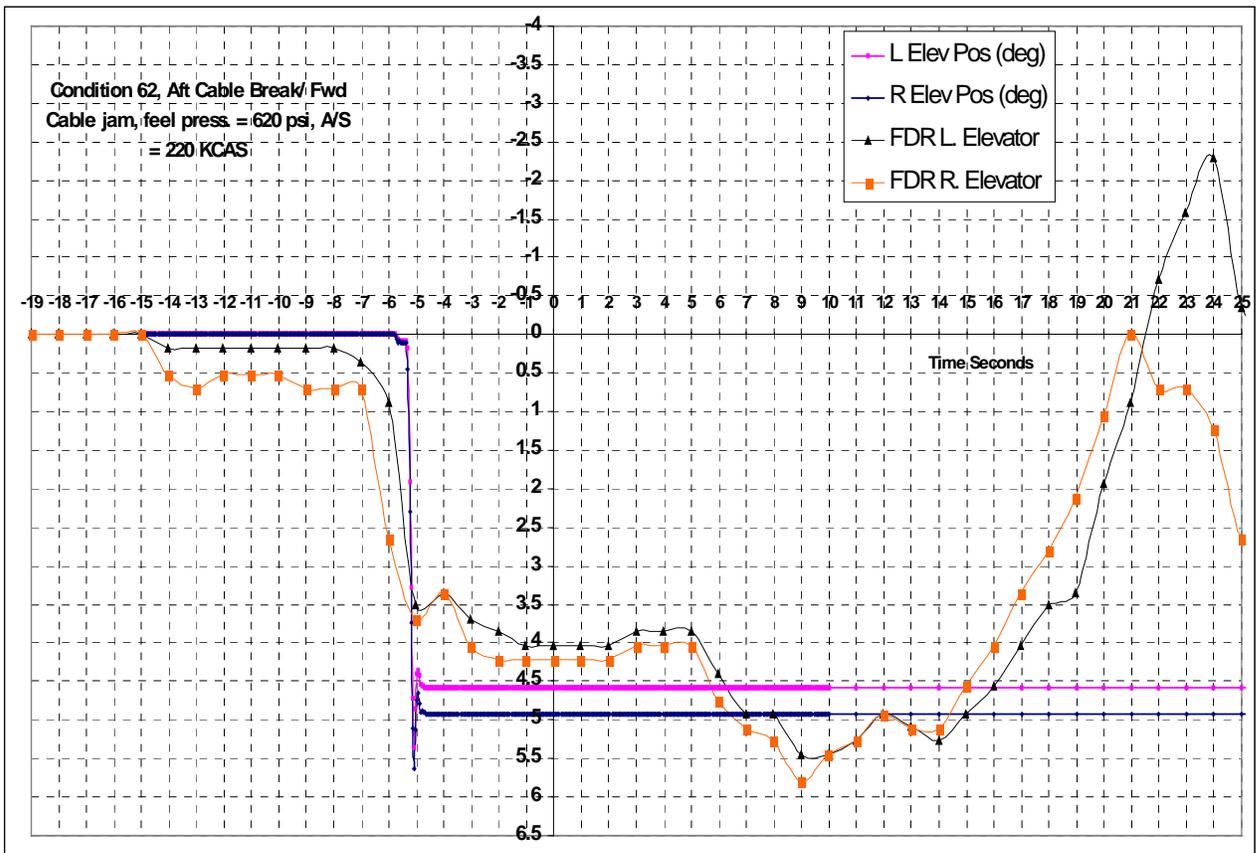
Figure 6, Condition 62 transient response

Figure 6 is an extract of the test condition 62 “Aft cable break, forward cable jam with elevator feel pressure = 620 psi, Airspeed = 220 KCAS”

These figures are constructed by removing all the initial biases for the elevator data extracted from the Ground Tests and the initial biases for the elevator data extracted from MS990 FDR to start with zero elevator deflection, for an objective comparison. These Figures show that the above shown failures result in rapid movement of the elevator surfaces, which is consistent the accident scenario.

- For evaluating stage 3 (First elevator position after the elevator rapid movement), Figures 6,7,8 (Conditions 62,122,150 respectively), also show the values of the first elevator position as shown by the FDR, and the elevator position resulting from inserting the failure during ground test.

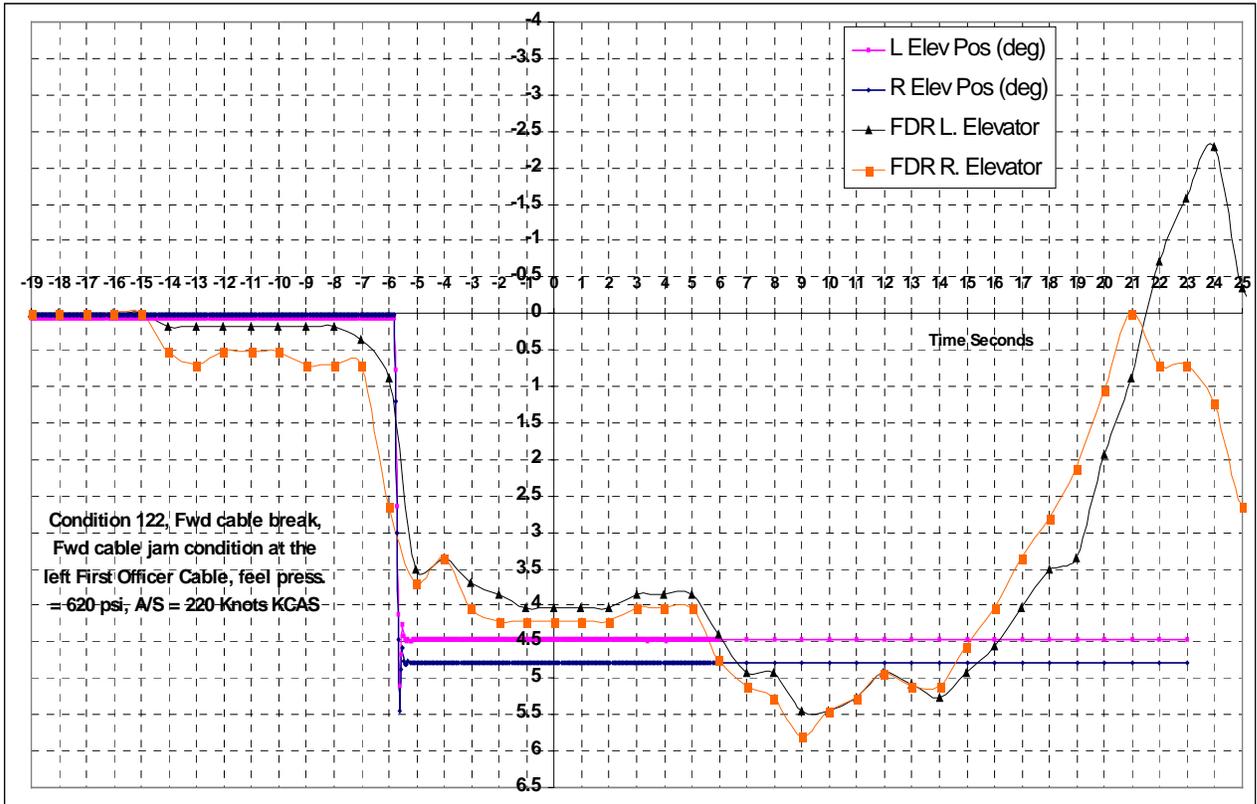
Figure 7, Condition 122 transient response

Figure 7 is an extract of the test condition 122 “ Fwd cable break, forward cable jam with elevator feel pressure = 620 psi, Airspeed = 220 KCAS “

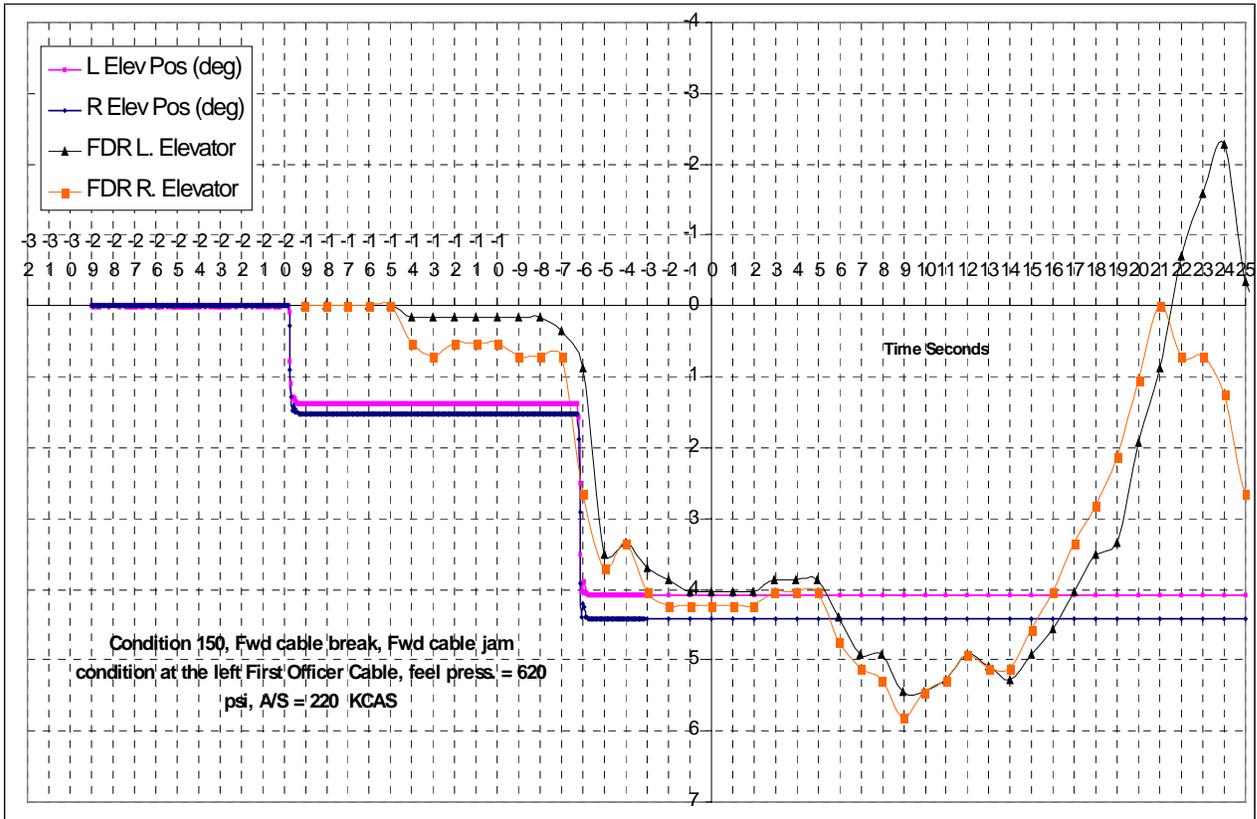
Figure 8, Condition 150 transient response

Figure 8 is an extract of the test Condition 150 ” Fwd cable break, forward cable jam with elevator feel pressure = 620 psi, Airspeed = 220 KCAS, transient response with R A/P, then A/P is disengaged”

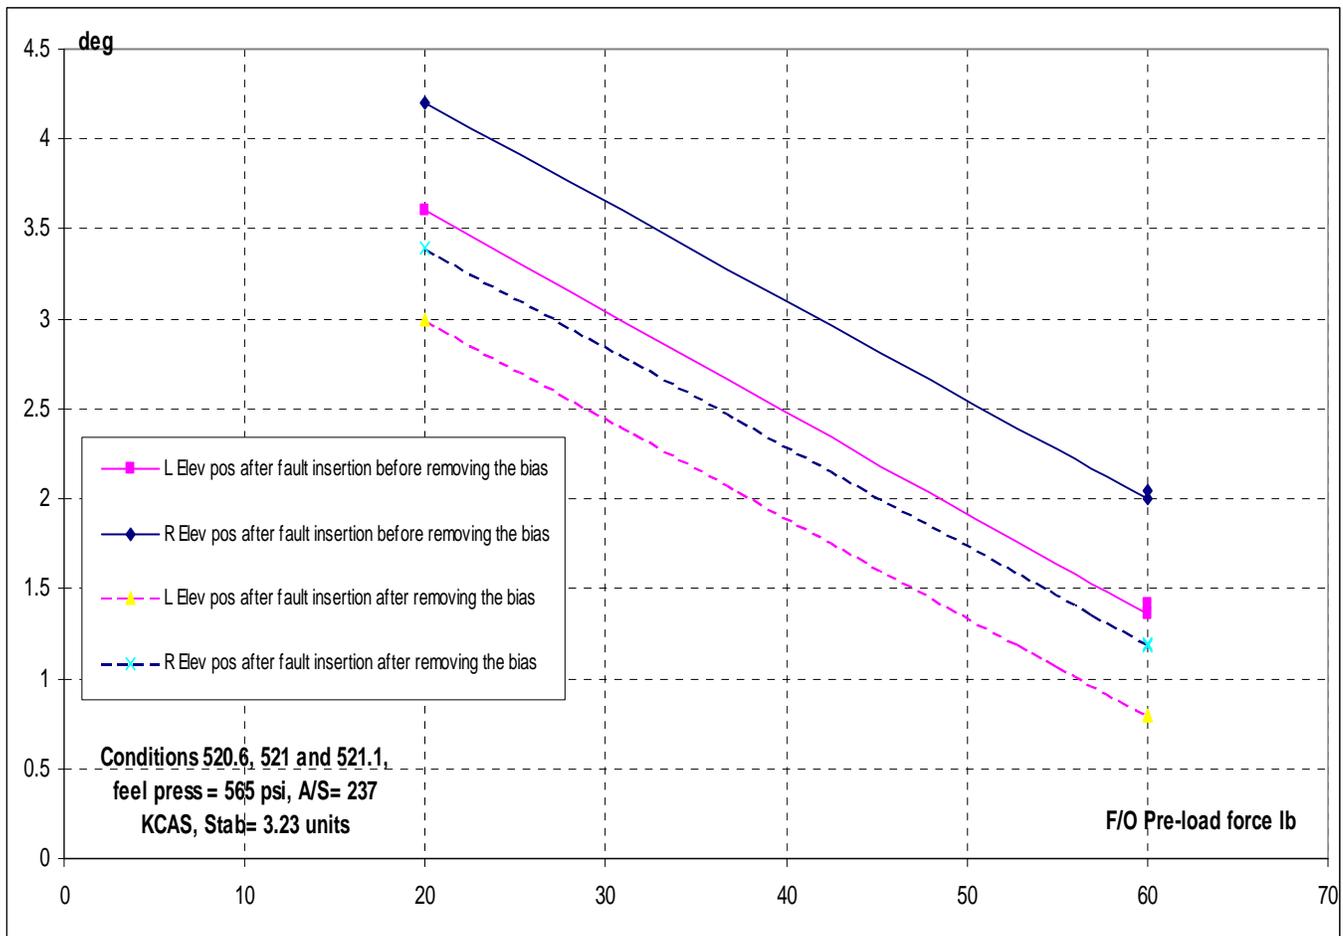
Figure 15, F/O pre load, condition 520.6, 521, 521.1

The above shown figures show that the shown failures can produce elevators deflection consistent with the FDR data with a pre-load force on the F/O elevator column

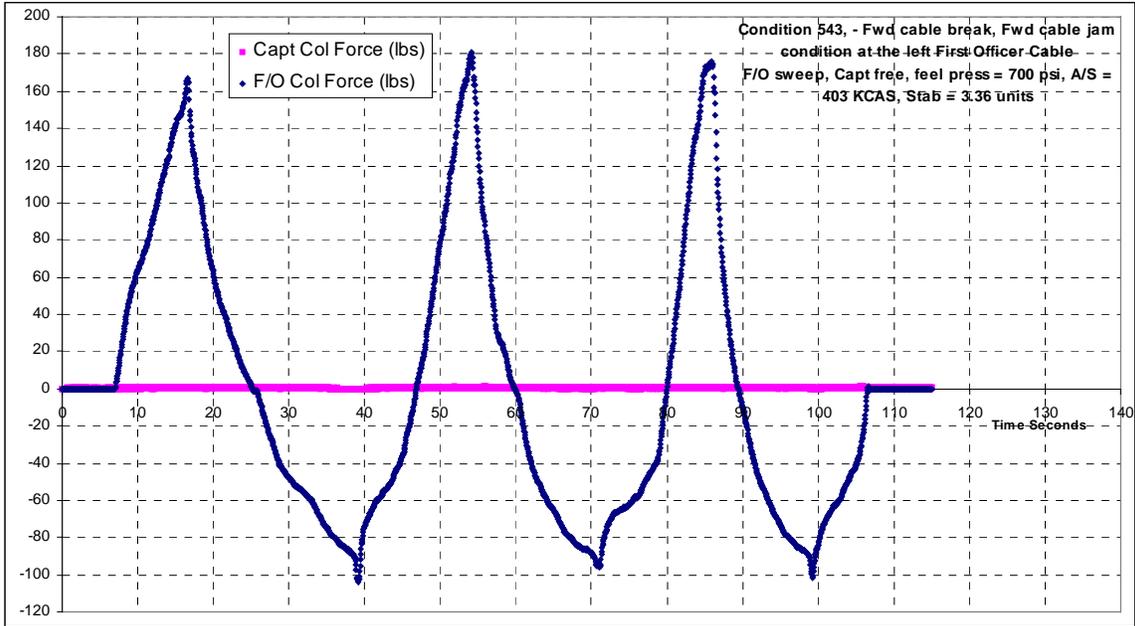
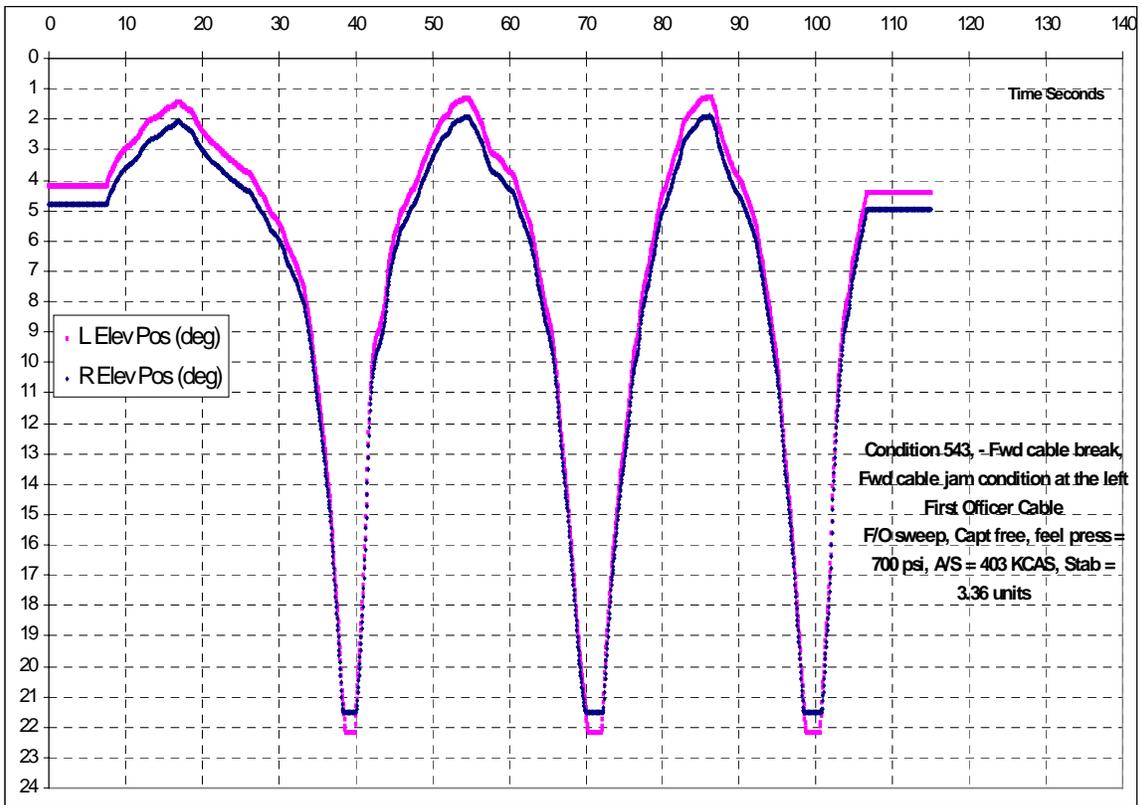
Figure 17, F/O sweep, condition 543

It is to be noted that with the failure conditions 543, 541 “Fwd elevator cable break with fwd end of broken cable jammed”, it was possible to drive the two elevators symmetrically, but it was not possible to drive the elevators to the neutral position from the F/O side.

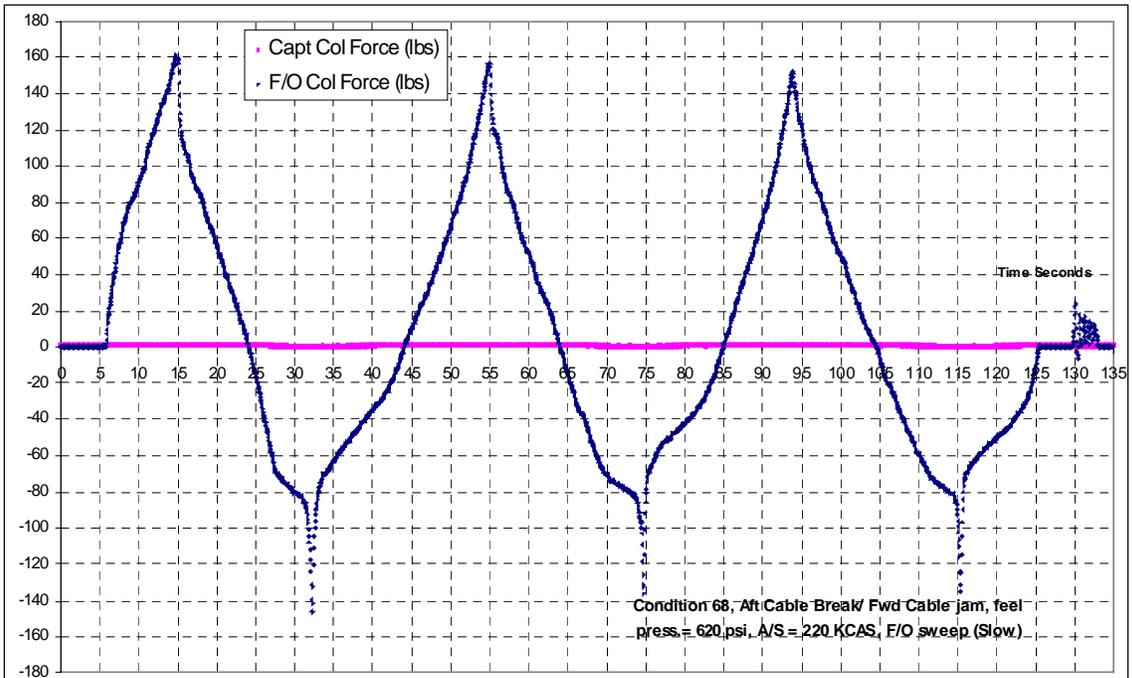
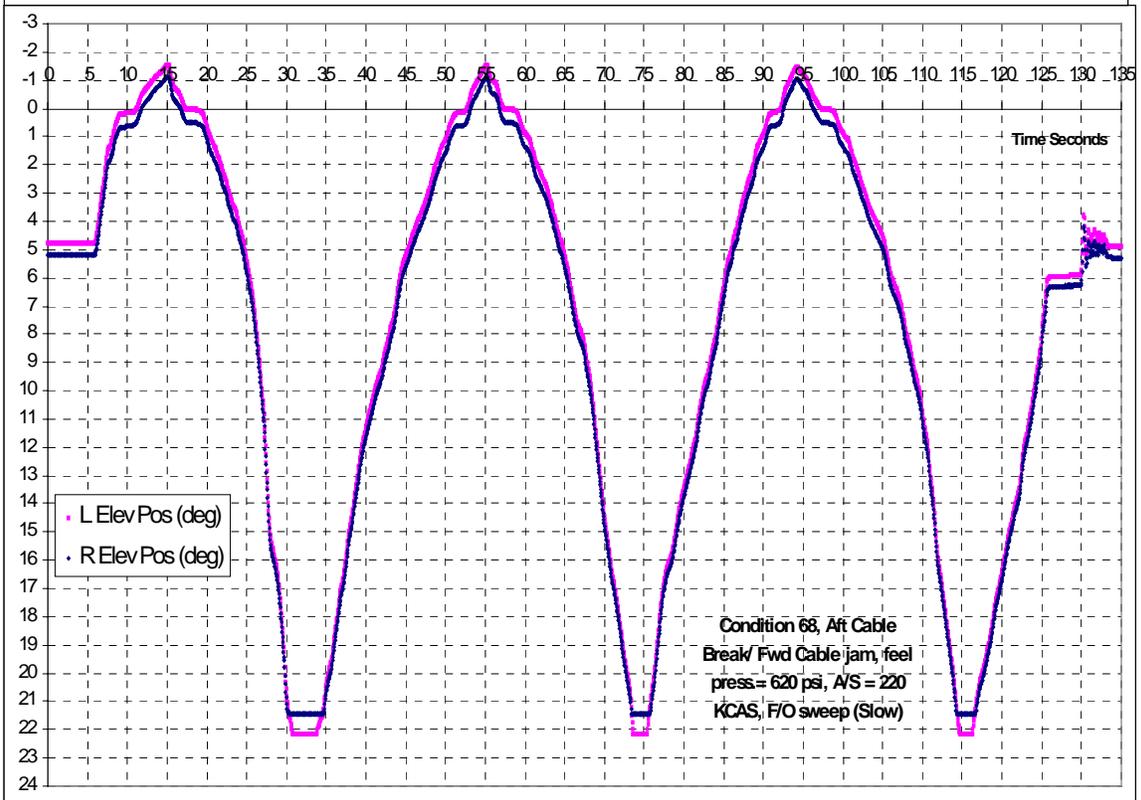
Figure 19, F/O sweep, condition 68 “Aft elevator cable break with fwd end of broken cable jammed”. The figure shows that it is possible to drive the elevators from the F/O elevator column and reach the neutral position (about 1 degree TEU).

Based on the limited available test data processed by the Egyptian Investigation Team, the failure condition “Aft elevator cable break with fwd end of broken cable jammed”, shows a very close consistency with the elevators FDR data during the dive warranting further tests.

The investigation should include tests to assist in more complete and precise analysis, including more detailed tests for the failure condition “Aft elevator cable break with fwd end of broken cable jammed”, taking into account the dynamic loads on the elevator surfaces, use of more consistent elevator feel pressures.
